Some Referenced Pointing Problems.

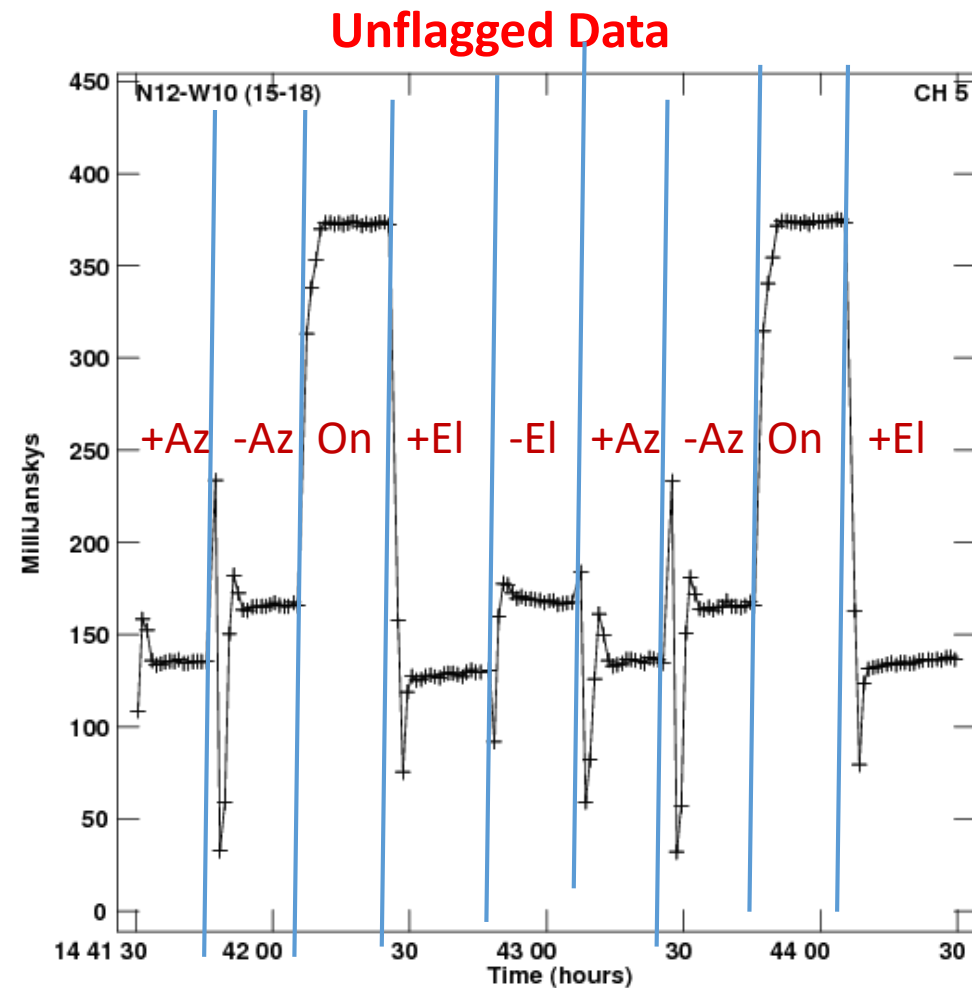
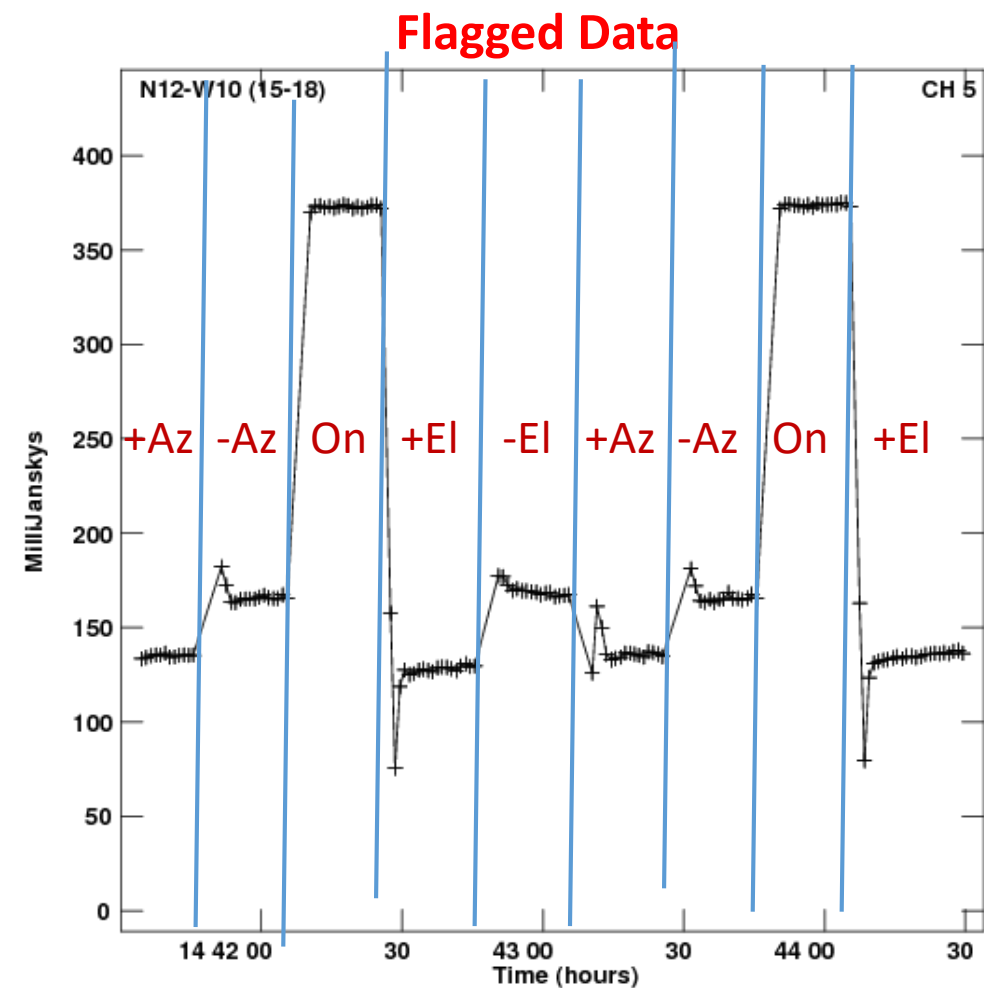
Old ACU – ea15 x ea18 Visibility Amplitudes

Old Antennas are getting proper flags. The only issue is the antenna overshoot and subsequent oscillations – not detected by encoders.

Easiest thing to do is to utilize only the last 10 – 12 seconds of each position.

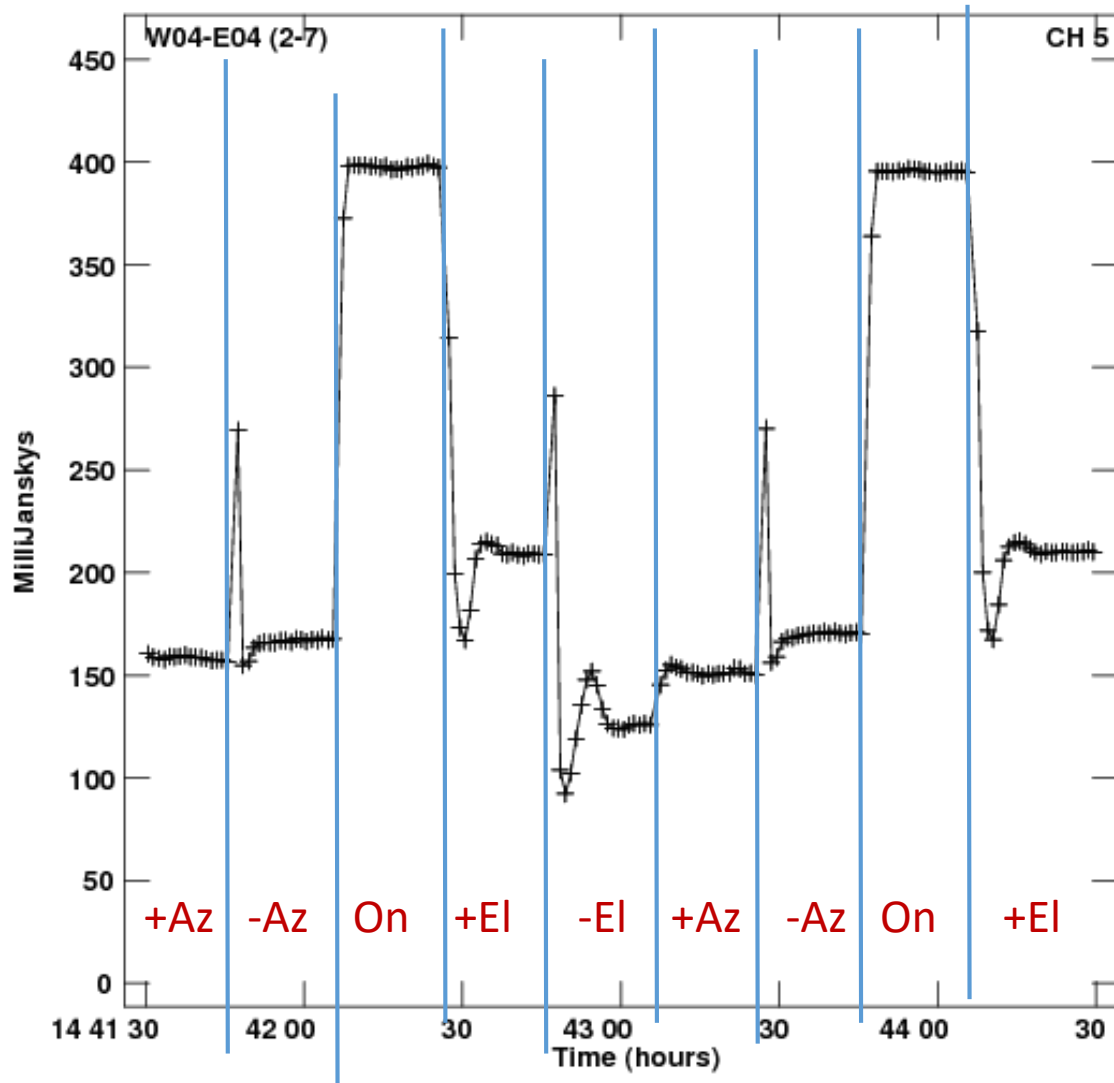
New ACU – ea02 x ea07 Az=196, El = 57.

- Only one plot here, as there were no system flags to apply.
- Most baselines look like this.
- For other baselines, some of the data taken during antenna motion were flagged.
- There are two issues:
 1. The high single values (when the antenna goes through the beam) are not being flagged. These data are then being used for the pointing solution.
 2. There is a large overshoot between +El and -El positions, with a 10-second period. This is unique to the New ACUs – and all of them show it.
- For some observations, the entire 20 seconds at the --El position is dominated by these slow oscillations.
- This oscillation is a new-ACU feature – should be able to remove it.
- Effects of this are much reduced if we utilize the last 10 – 12 seconds of data from each position.
